**ADDITIONAL  
MAINTENANCE INSTRUCTIONS**

**NAVY TYPE ACB-1600HR  
CIRCUIT BREAKER**

**WESTINGHOUSE TYPE DBN-1016**

**TECHNICAL MANUAL 32-855-11C1**

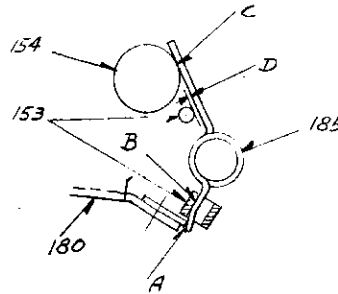
RESETTING

CHECK TO SEE IF TRIGGER (180) WILL RESET FROM THIS POSITION AND IF NECESSARY CLEAN AND REMOVE BURRS FROM SURFACE "E" ON LATCH (153)

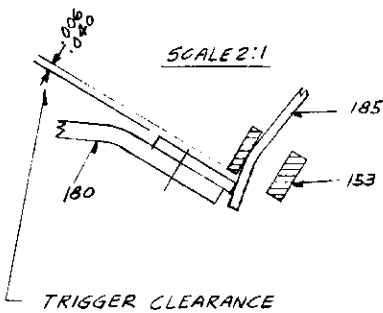
LATCH POSITION

WITH TRIGGER (180) TOUCHING SPRING (185) ON SURFACE "A" AND WITH SPRING (185) TOUCHING LATCH (153) ON SURFACE "B" THEN IF NECESSARY BEND UPPER END OF SPRING SO THAT SPRING

1. TOUCHES PIN (154) AT "C"
2. AND HAS ZERO TO .016 INCH CLEARANCE TO PIN PROJECTION OF LATCH (153) AT "D"

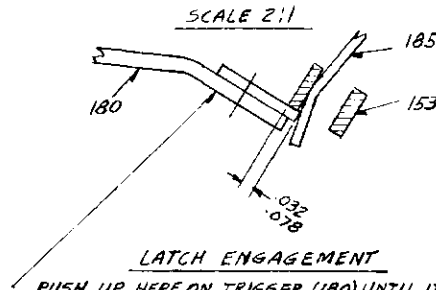
304 8531  
304C 398  
Fig. 1 - Mechanism Latch Adjustment

BEND END OF TRIGGER (180) IF NECESSARY TO ADJUST IF CLEARANCE IS LESS THAN .006 DO NOT BEND IF OVER .040 BUT CONTACT MANUFACTURERS REPRESENTATIVE

PUSH UP HERE ON TRIGGER (180) UNTIL IT TOUCHES LATCH (153) CHECK DIMENSION AND BEND END OF SPRING (185) IF NECESSARY

1. Failure of trip bar to reset, insufficient latch engagement, incorrect trigger clearance, or faulty latch position. See Figure 1 of this insert for details of inspection and correction.

1. Insufficient latch engagement, incorrect trigger clearance or faulty latch position. See Figure 1 for details.
  2. Any device which might hold trip bar in partially tripped position.
